Chang K-T, Yeh P-T, Hsiao Y-S, Wang C-Y and  
Chiu Y-C (2024), Deformation and collapse of  
rock slopes considering weak plane  
orientation.

*Front. Earth Sci.* 12:1402027.

# Deformation and collapse of rock slopes considering weak plane orientation

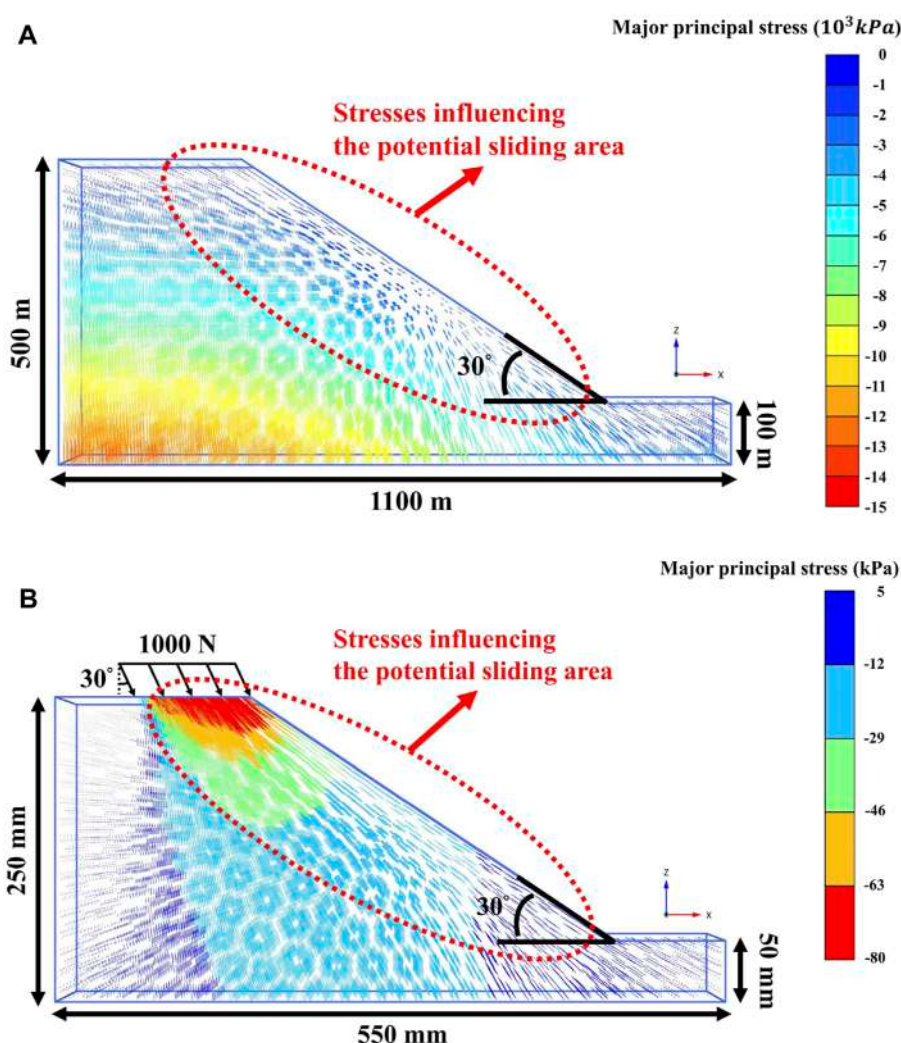
FIGURE 1  
3D numerical simulation to show directions of major principal stresses in a slope (A) full-size slope (B) physical slope model adopted in this case.

The stresses in a real slope (the slope angle of 30° and the slope height of 400 m) are simulated using three-dimensional software Plaxis 3D under elastic behavior with a unit weight of 26 kN/m<sup>3</sup>, a Young's modulus of 2 GPa, and a Poisson's ratio of 0.3. The numerical results show that the major principal stress directions dip gently near the slope surface but are steeper in areas away from the surface (Figure 1A). Considering the depth within 100 m, the average major principal stress direction is approximately 30° to the vertical direction. Therefore, the physical slope models were deformed to failure by applying an inclined load of 30° to the vertical direction at the top of the slope model. The stresses in the small-scale slope model are also shown in the numerical results (Figure 1B), using the Mohr-Coulomb model and the aforementioned elastic and strength parameters of the cemented sand. Taking the load of 1000 N as an example, the influenced area in slope model has approximately similar major principal directions with the real slope.

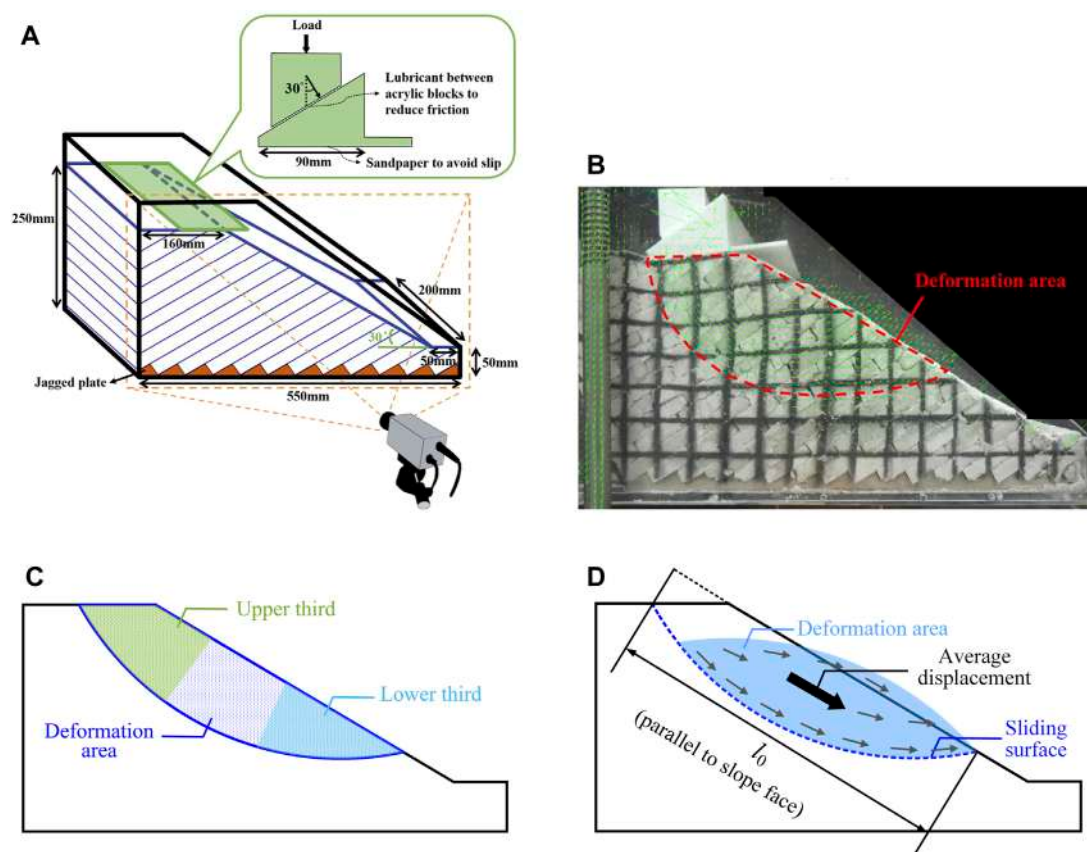
FIGURE 2

(A) Configuration of the physical slope model and deformation analysis of the physical slope model, (B) deformation area, (C) the upper third and lower third of the deformation area to calculate the velocity ratio (VR), and (D) average displacement in the deformation area.

Figure 2A shows the configuration of the physical slope model with a fixed slope angle 30°. Weak planes with four dip angles were adopted, namely, there are anaclinal slopes with weak plane dip angles of 30° and 60° and cataclinal slopes with weak plane dip angles of 30° and 20°, which weak planes daylight at. Two spacing values for the weak plane, 20 mm and 15 mm, were used in this research. Jagged plates were fixed at the bottom of the acrylic model box to

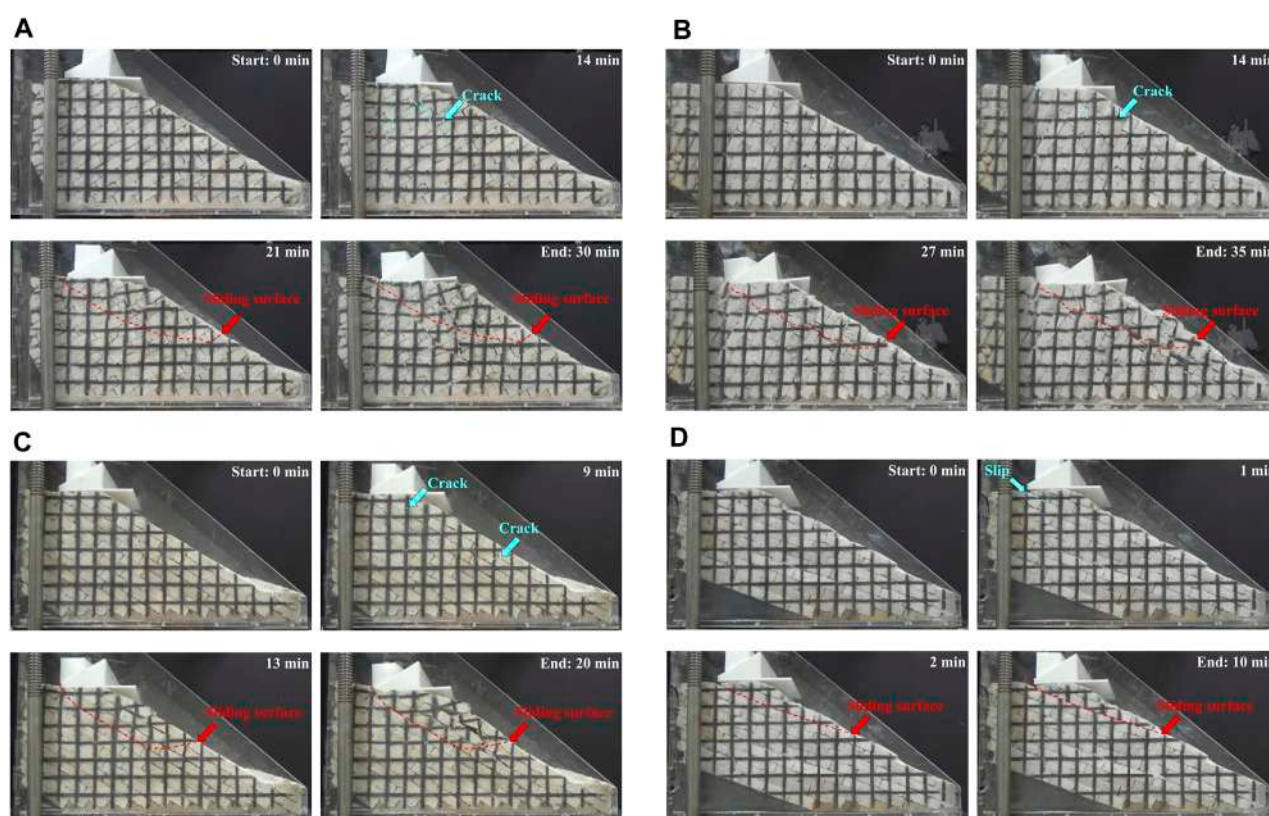
**FIGURE 3** Deformation process of the physical model with 20 mm weak plane spacing, (A) anaclinal slope with weak plane dip angle 30°, (B) anaclinal slope with weak plane dip angle 60°, (C) cataclinal slope with weak plane dip angle 30° and (D) cataclinal slope with weak plane dip angle 20°.

cataclinial slope with a 20° weak plane, sliding along weak planes appears at the slope top (Figure 3D) after loading for 1 min. During the second minute, the cracks extend to the slope surface, and the displacement of the sliding body rapidly accumulates afterward.

The deformation processes of the four cases with different weak plane orientations are similar, either with 15 mm or 20 mm weak plane spacing (Figures 3, 7). Cataclinal slopes with daylighting weak planes (20° weak plane) sustain exceptionally small load values

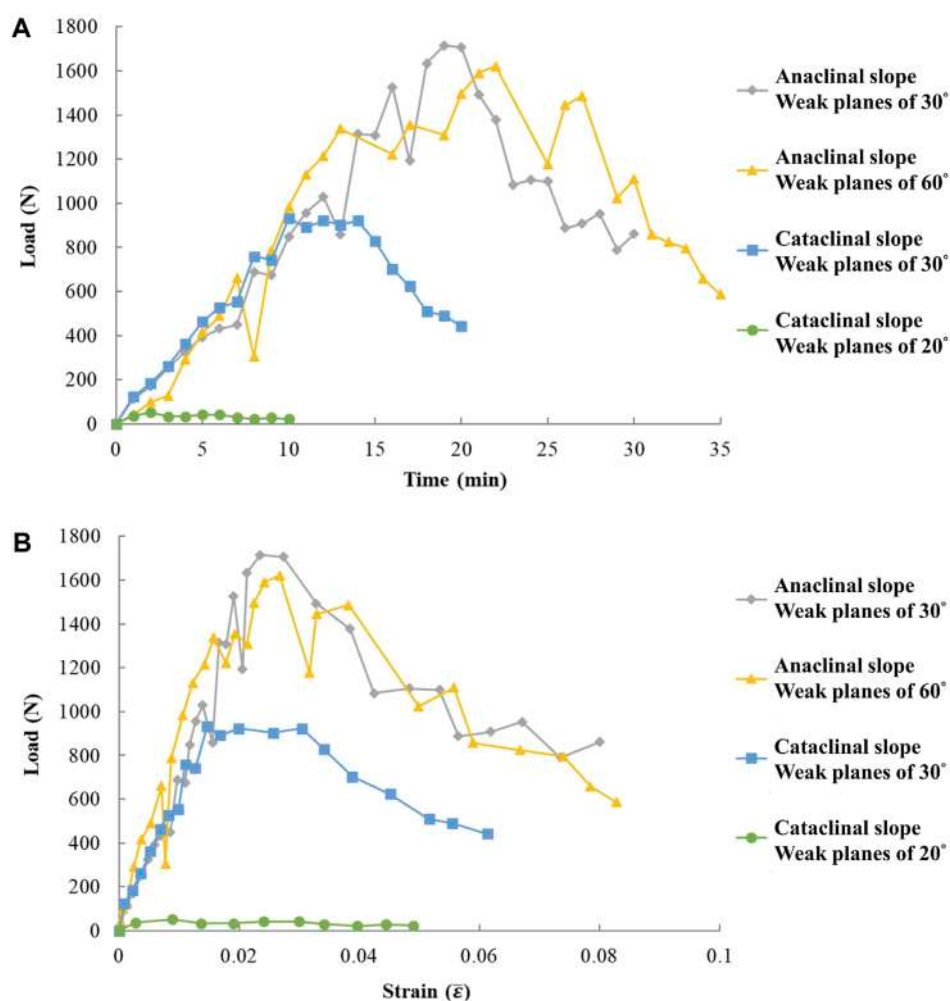
FIGURE 4  
Experimental results of 20 mm weak plane spacing: relationship of (A) load and time, (B) load and average strain of the deformation area.

The bearing capacities of the four types of slopes are different, as are the changes in average velocity, average strain of deformation area, and VR with time. Figure 4A shows the relationship between load and time. The load represents the vertical load exerted by the apparatus, which is greater than the inclined load on the

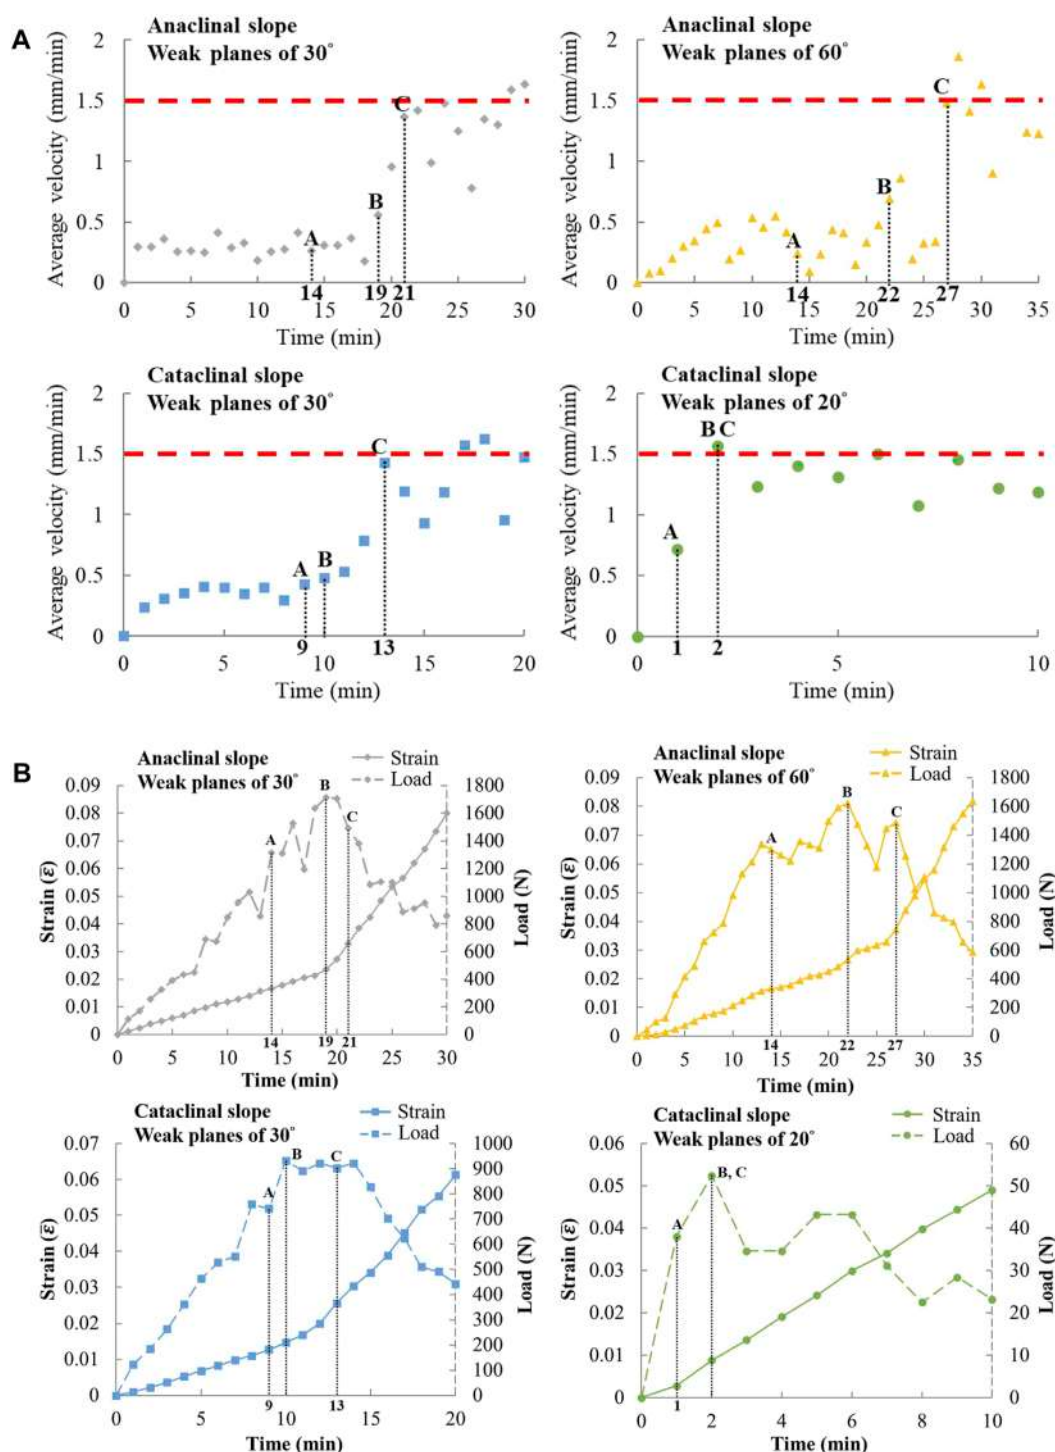
FIGURE 5

Experimental results of 20 mm weak plane spacing: (A) average velocity and time, (B) average strain and time [A: local failure initiation, B: peak load, C: sliding surface cuts through the slope].

top surface of the slope. The slopes considering the peak loads in descending order are as follows: the anaclinal slope with 30° weak planes, anaclinal slope with 60° weak planes, cataclinal slope with 30° weak planes, and cataclinal slope with 20° weak planes. Among them, the weak planes daylight in the cataclinal slope with 20° weak planes, and the sliding surfaces in such cases slide along the weak planes without cutting through the artificial cemented sand plates. Therefore, the peak load, which is much smaller than the other three types of slopes, mainly originates from the weak-plane friction angle. Figure 4B shows the load-average strain relationship. Hereafter, the average strain of the deformation area at collapse is referred to as the critical strain. The slopes showing the critical strain from the greatest to the least ones are the anaclinal slope with 60° weak planes, the anaclinal slope with 30° weak planes, the cataclinal slope with 30° weak planes, and the cataclinal slope with 20° weak planes. Notably, the anaclinal slope with 30° weak planes has a larger peak load than the anaclinal slope with 60° weak planes, but the former carries merely a slightly smaller critical strain than the latter. Additionally, the oscillation in anaclinal slopes reflects local failure inside the slopes, which is absent in cataclinal slopes (Figure 4). Every local failure induces an increase in displacement and strain, but as these phenomena lead to a dislocation between artificial plates and the loading acrylic block, the load decreases. As the loading continues, the loads increase again. The variations in the average velocity and average strain in the deformation area and load are shown in Figure 5. Throughout the experiments, there

are three distinct points, namely, A. crack initiation (local failure initiation), B. peak load and C. sliding surface cuts through the slope. These points were determined based on the video images (Figure 4) and load-time and load-average strain curves (Figure 5). Local failure initiation always occurs before the peak load, and the sliding surface cuts through the slope after or at the peak load. The red dashed line in Figure 5A represents the loading velocity of the hydraulic machine, i.e., 1.5 mm/min. After point C, the deformation area detaches from the slope and forms the sliding body. The sliding body tends to move at rates close to the loading velocity; i.e., the sliding body moves the same amount as the hydraulic machine (Figure 5A). The increase in average velocities (Figure 5A) corresponds to the increase in average strain (Figure 5B). Approximately after the peak load, the average velocity and average strain increase drastically, and the sliding surface cuts through the slope.

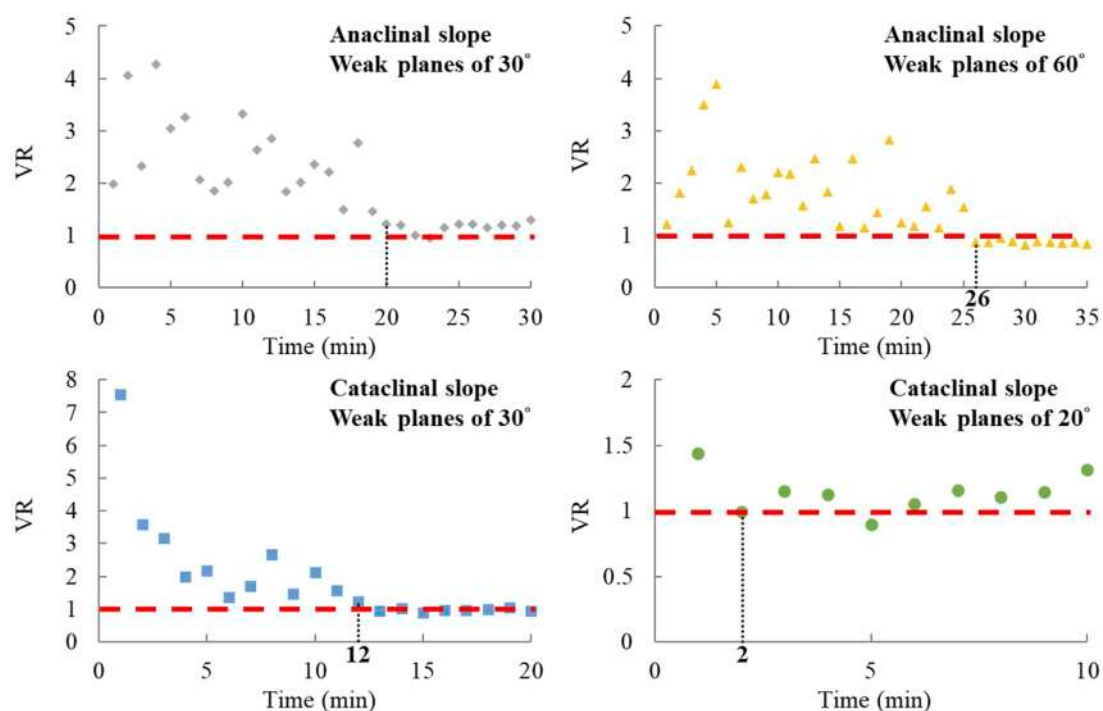
**FIGURE 6**  
Experimental results of 20 mm weak plane spacing: change of velocity ratio (VR) with time, the vertical dashed line and its corresponding number indicates the time when VR approaches 1.

The change in VR with time manifests the developing process of the sliding surface (Figure 6). VR approaches 1.0 as loading increases with time, signifying that the upper and the lower parts of the sliding body move at similar rates. The first time VR meets 1.0 is very close to the time when the sliding surface cuts through the slope (point C in Figure 5). In addition, cataclinal slopes with 20° weak planes can move easily along the weak plane. Therefore, such a case reaches peak load (point B in Figure 5) shortly after local failure (point A in Figure 5), and then the sliding surface cuts through the slope, making VR approximately 1.0.

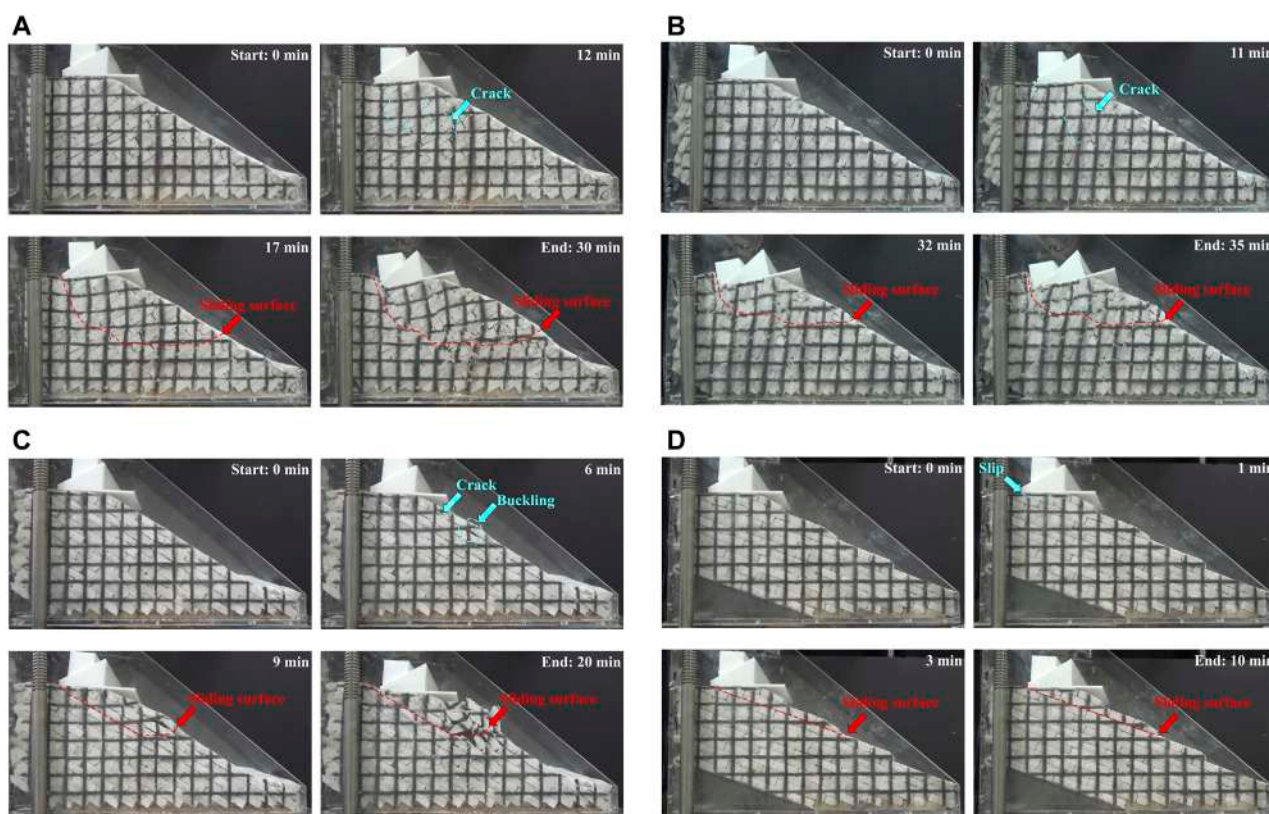
**FIGURE 7**  
Deformation process of the physical model with 15 mm weak plane spacing, (A) anaclinal slope with weak plane dip angle 30°, (B) anaclinal slope with weak plane dip angle 60°, (C) cataclinal slope with weak plane dip angle 30° and (D) cataclinal slope with weak plane dip angle 20°.

The test process of the 15 mm-spacing model is shown in Figure 7, which is similar to the slope model with spacing of 20 mm. In the process of loading, cracks appear first; i.e., local failure occurs, the sliding surface cuts through the slope, and then the sliding body moves substantially along the sliding surface. Notably, the load direction changes due to the slight inclination of the lower acrylic block after the sliding surface cuts through the slope and significant movement occurs (Figures 7A, B). In comparison of the shapes of the sliding surfaces, the tilt of the acrylic block may be attributed to the more curved shape of the sliding surface causing rotation of the sliding body after large displacement. For cases with 15 mm spacing, the peak loads of slopes in descending order are as follows: anacinal slopes with 30° weak planes, anacinal slopes with 60° weak planes, cataclinal slopes with 30° weak planes, and cataclinal slopes with 20° weak planes (Figure 8). This is identical to cases with 20 mm spacing. For the critical strain,

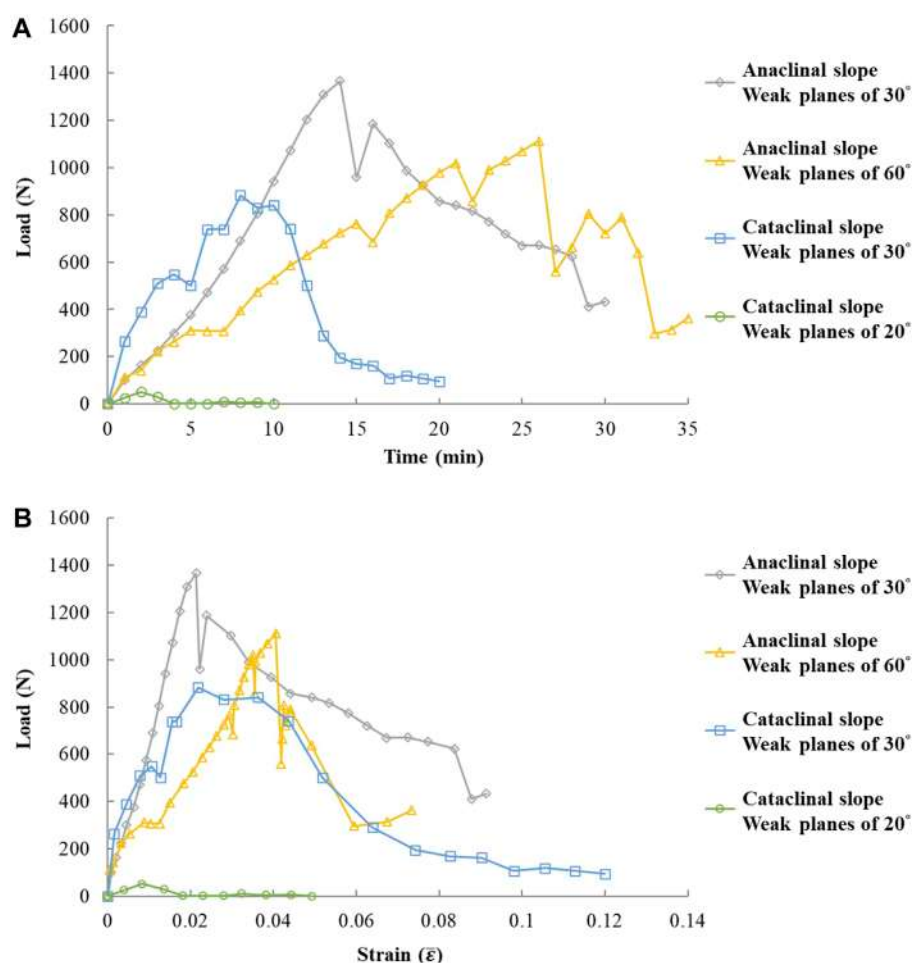
FIGURE 8  
Experimental results of 15 mm weak plane spacing: relationship of (A) load and time, (B) load and average strain of the deformation area.

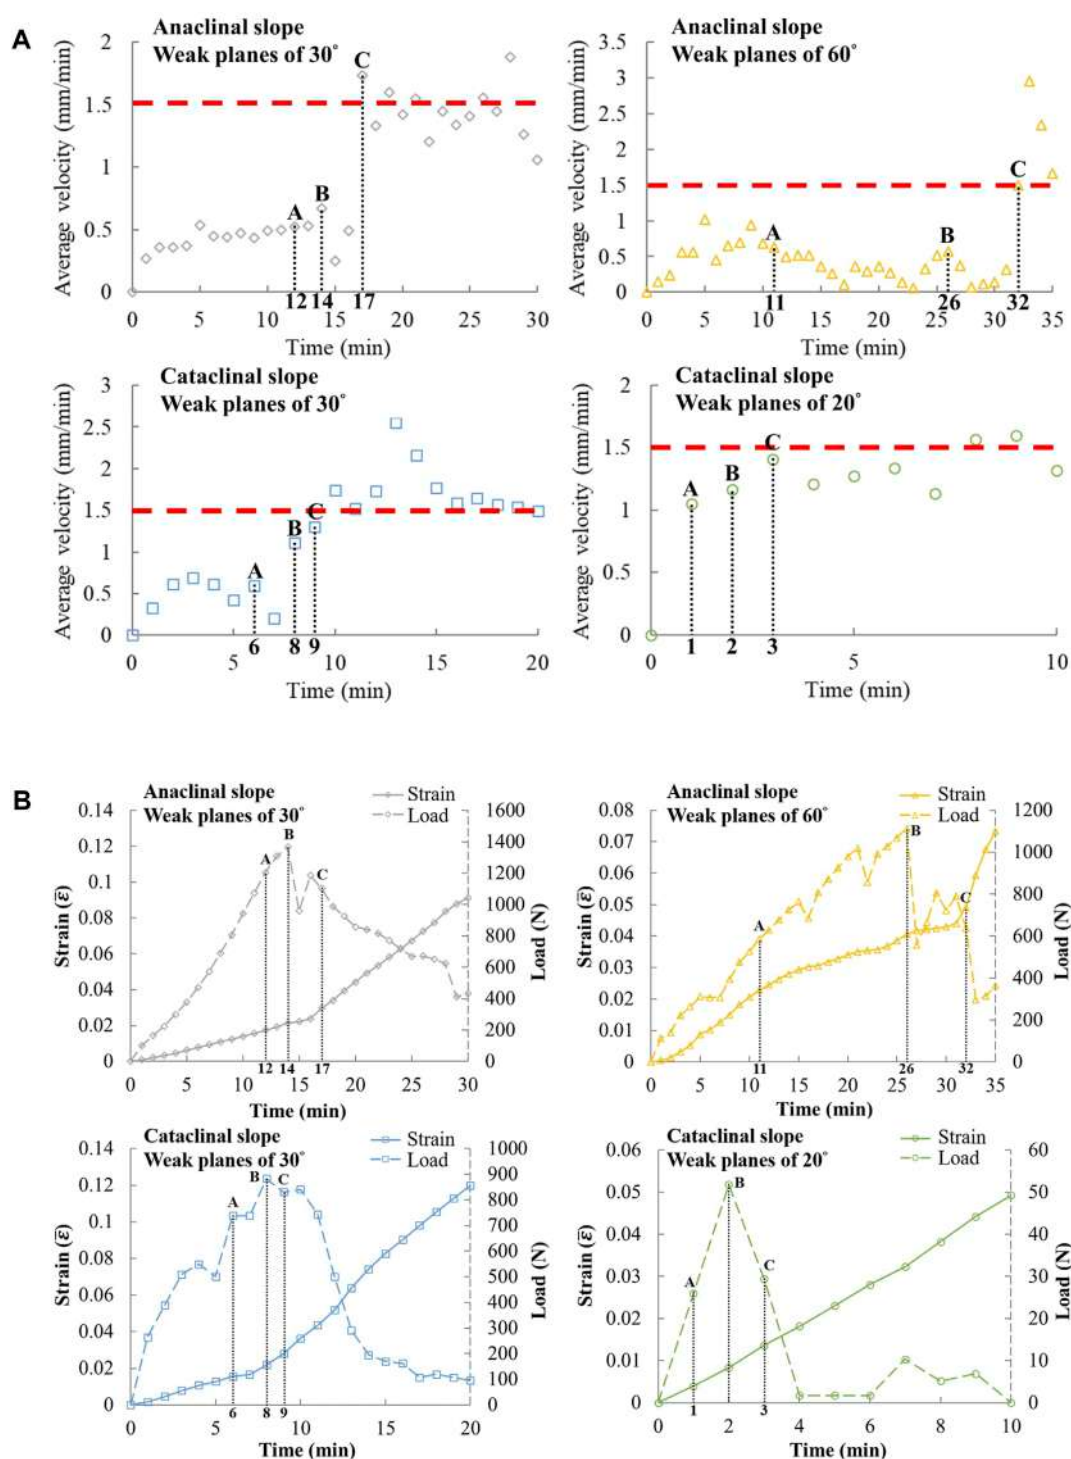
FIGURE 9

Experimental results of 15 mm weak plane spacing: (A) average velocity and time, (B) average strain and time (A: local failure initiation, B: peak load, C: sliding surface cuts through the slope).

In Figure 9, the occurrence times of A. local failure, B. peak load, and C. the sliding surface cuts through the slope were determined according to Figures 7, 8A. The variation trends are approximately the same as the cases with 20 mm spacing (Figure 5). First, cracks appear, and then local failure takes place until the peak load. After the peak load, the average velocity and average strain increase with time, and the average velocity maintains approximately the loading rate (1.5 mm/min) after the sliding surface cuts through

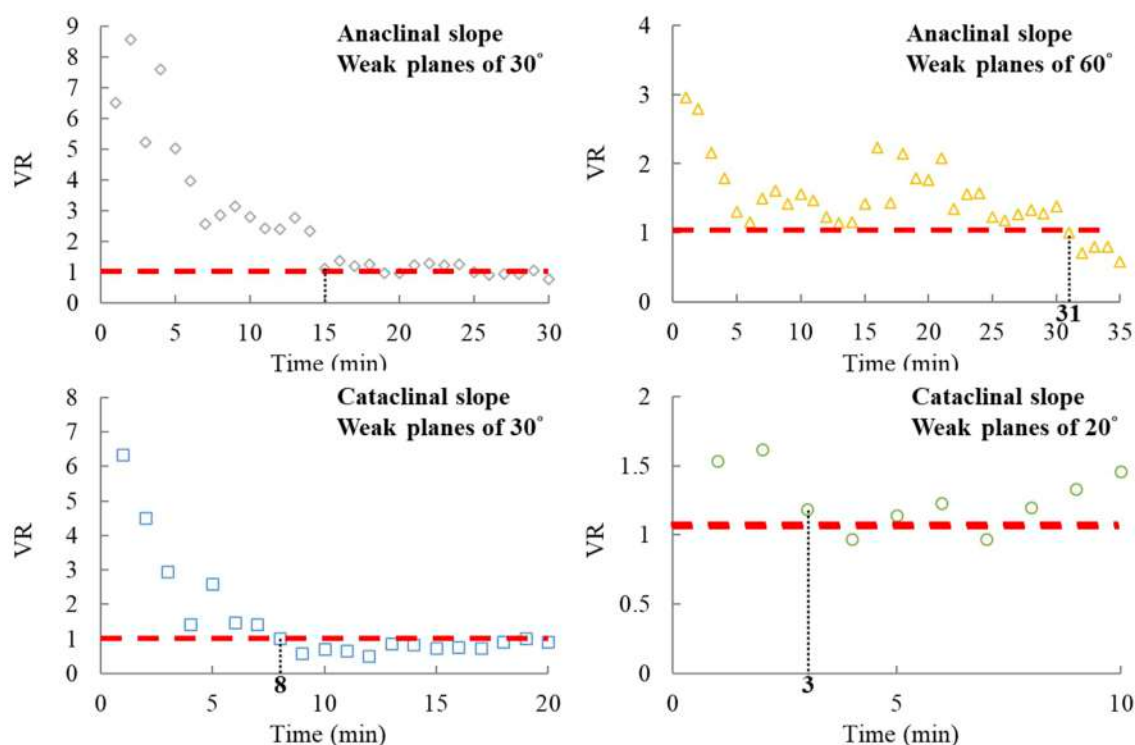
FIGURE 10

Experimental results of 15 mm weak plane spacing: change of VR with time, the vertical dashed line and its corresponding number indicates the time when VR approaches 1.

the slope (Figure 9).  $V_R$  decreases progressively with increasing loading, suggesting that cracks first appear in the upper part of the deformation area, then develop downward. Eventually, the upper and the lower parts of the deformation area detach together from the remaining slope and move along with loading (Figure 10).

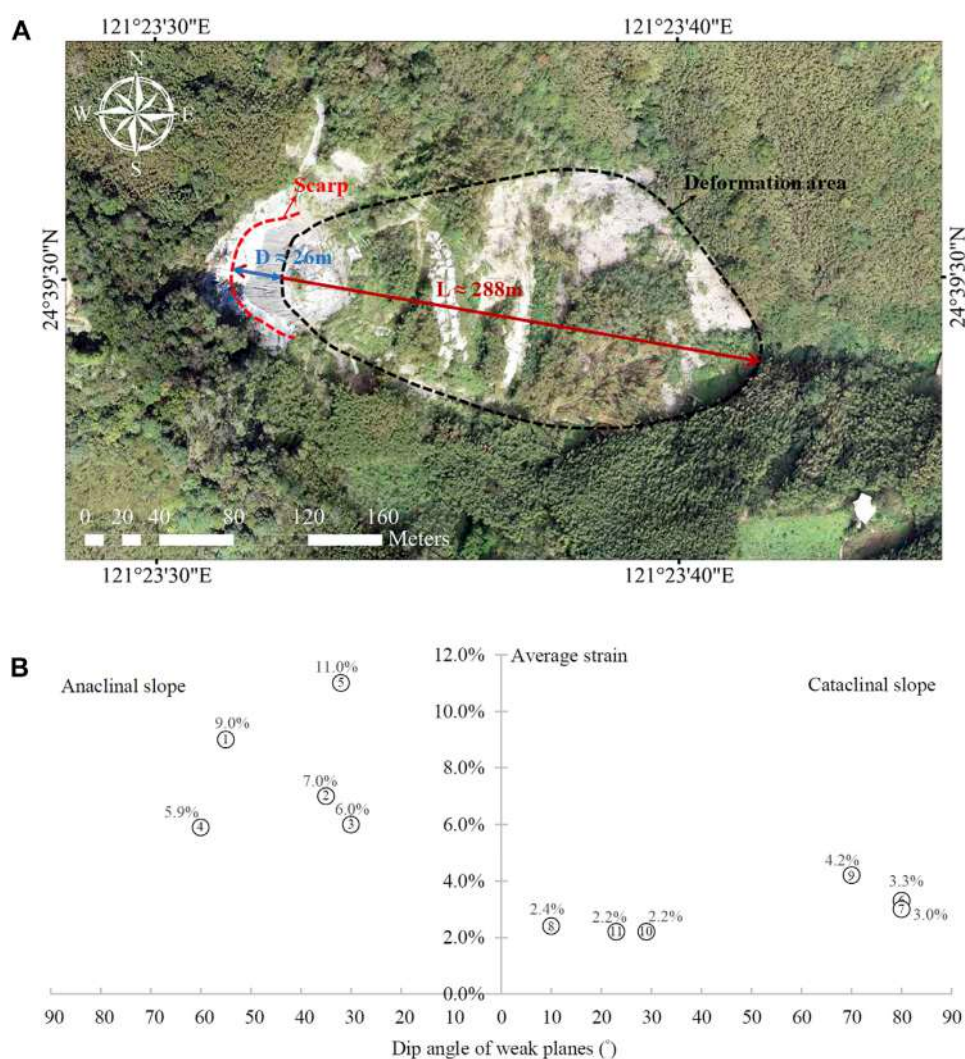
FIGURE 11

(A) The scarp length ( $D$ ) and the length from the top of the scarp to the toe of the deformation area ( $L$ ) in the aerial photo of the Guanghua slope, (B) average strain of real slopes.

where  $d_o$  is the scarp length along the slope direction rather than average displacement of the deformation area in Eq. 2;  $l_o$  has the same definition as in Equation 2;  $D$  is the scarp length in the aerial photo;  $L$  is the length from the top of the scarp to the toe of the deformation area in the aerial photo;  $\beta$  is the average slope angle. Figure 11A shows the topographic features of the Guanghua slope for estimating the average strain.

In order to verify the trend of critical strain obtained from experiments, some potential large-scale landslide cases that have the topographic features to estimate their average strain are compared in Table 1 with respect to cataclinal and anaclinal slopes. These real slope cases are mostly comprised of argillite, slate and metasandstone, where six of them are cataclinal slopes and five are anaclinal slopes. Similar to experimental results, the real slopes show the trend that the anaclinal slopes exhibit greater average strain than the cataclinal slopes (Figure 11B).

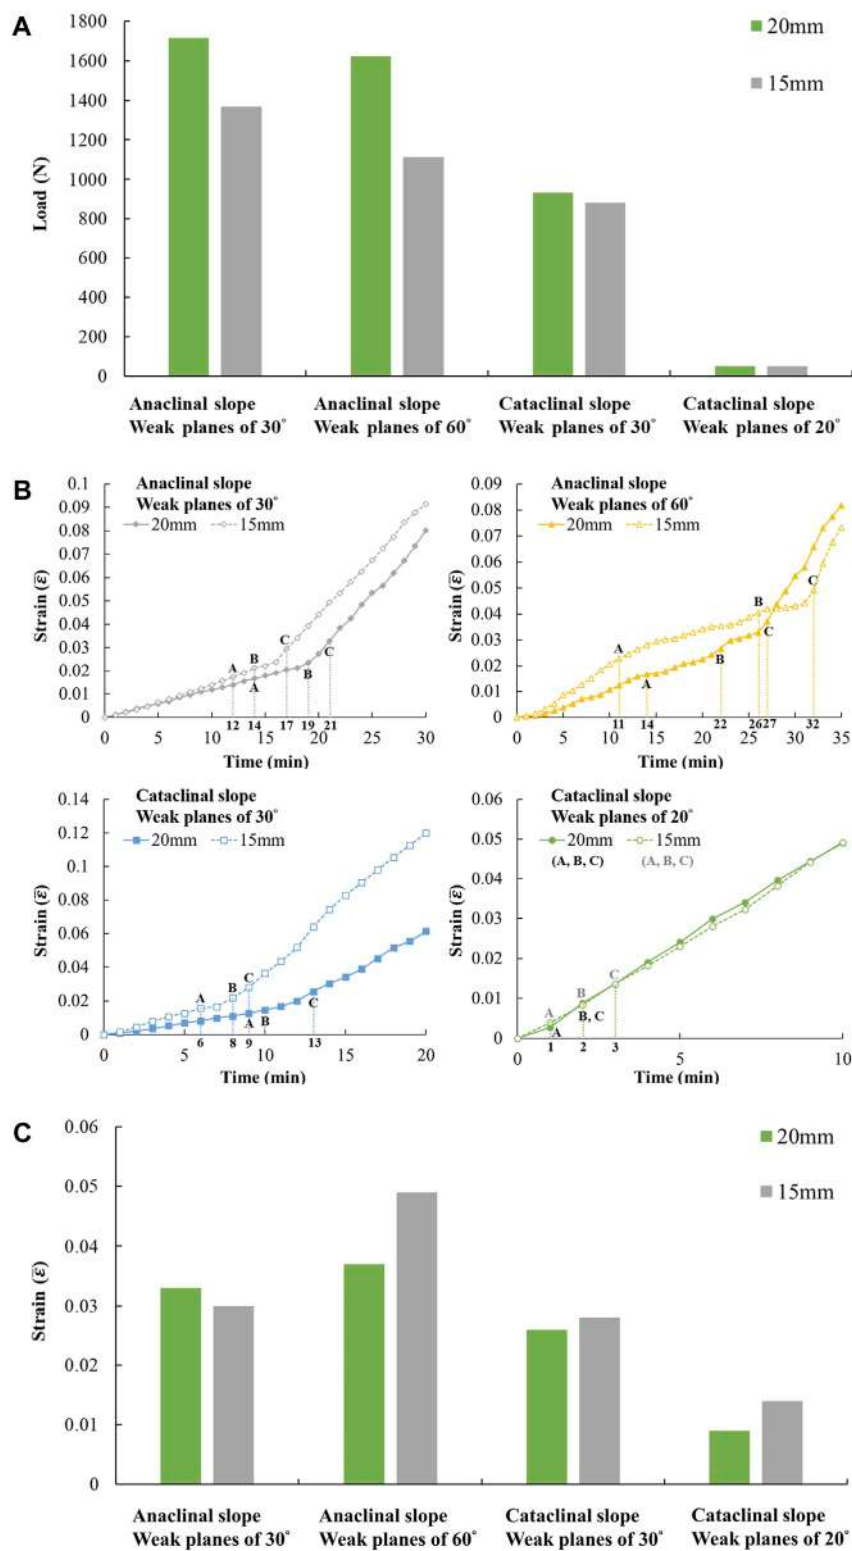
FIGURE 12 (A) Comparison of peak load between different values of weak plane spacing and comparison between different values of weak plane spacing, (B) average strain and time, (C) critical strain, the average strain as the sliding surface cuts through the slope.

(Figure 12A) among these cases. The cases with a larger spacing present a higher bearing capacity. The average strain-time relation generally exhibits one turning point, which is close to point C, when the sliding body cuts through the slope (Figure 12B). Before point C, the average strain rates of cases with larger spacing are usually smaller, except for cataclinal slopes with daylighting weak planes. However, the results do not show a clear trend for the critical strains in comparison of two spacing values (Figure 12C). Table 2 lists deformation areas estimated through PIVlab. Regardless of the spacing, all slopes show that anaclinal slopes with 30° weak planes produce the largest sliding body and that cataclinal slopes with 20° weak planes develop the smallest sliding body.
